102 Metal Repair Fluid

is a two component solvent free epoxy fairing compound. The product has been designed to be applied to badly pitted surfaces up to 3mm in depth.

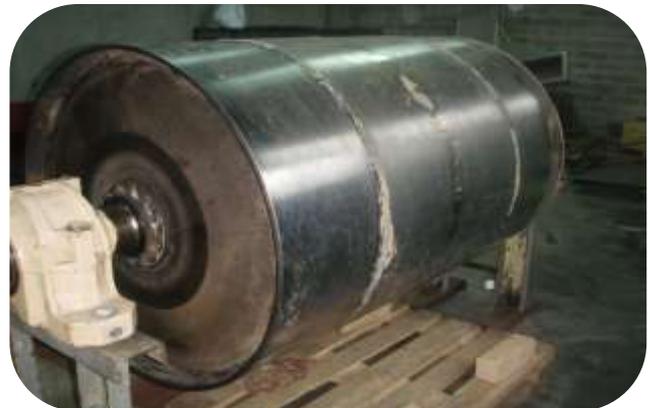
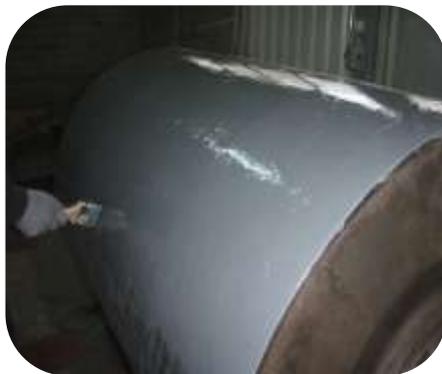
Conveyor belt roller prepared using needle guns and coated with 102 Metal Repair Fluid. Bauxite aggregate was incorporated into the wet resin to create an anti slip finish
